**Flood Control Project Maintenance  
Levee Inspections**  
**LMA District Cover Sheet**  
**Spring 2019 Levee Inspection Results**

**Sacramento River West Side Levee District**

**Spring 2019 Levee Inspection Results**

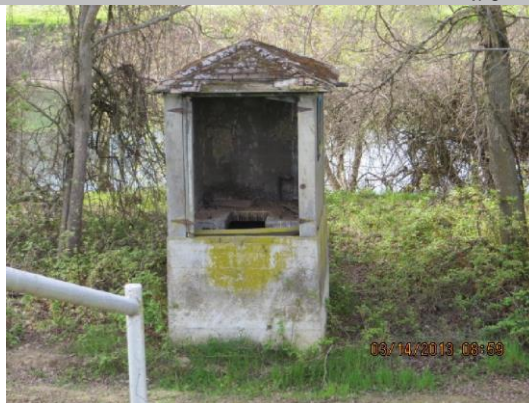
Photo 1 of 2 : UCIP\_SP\_2019\_10266\_17490.jpg

LM Start	22.71	Rating **	M	Issue No.	1575
LM End	22.71	Issue Type +	En	Location *	
Category	Supplemental			GPS Latitude/Longitude	
				Start	End
Item	DWR UCIP Field Study			38.989862 °	38.989862 °
				-121.805243 °	-121.805243 °
DWR ID	20248				
Comment Code					
Inspector Comment					
FS_ID:10266 DS_ID:20248 EP_NO: N/A Repair Type: Non-Urgent Crossing Status: Found UCIP Comments: Pipe needs to be verified as having been properly abandoned. FIELD_STRUCT_DESC: 24-inch irrigation pipe of an unknown material through the levee, 19.5 feet below the crown. Abandoned concrete pump house on the waterside (WS) toe. [Additional Reference(s): USACE Sacramento O&M Manual 130, May 1960 (HLM 22.99)]. FS Date: 3/14/2013

Concrete pumphouse on WS berm.

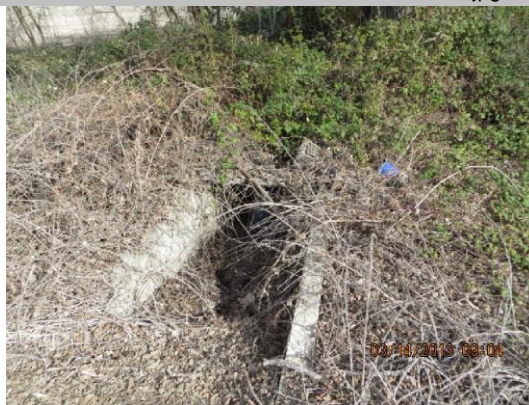
Photo 2 of 2 : UCIP\_SP\_2019\_10266\_17489.jpg

Concrete box on LS toe.

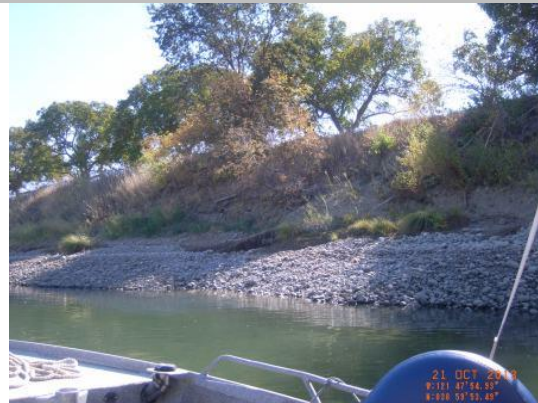
Photo 1 of 1 : SP\_2019\_NA0016\_435\_86\_20190304\_00021.jpg

LM Start	23.55	Rating **	A/W	Issue No.	86
LM End	23.65	Issue Type +	Ma	Location *	WS
Category	Supplemental			GPS Latitude/Longitude	
				Start	End
Item	2017 USACE Erosion Survey, DRAFT			38.997696 °	38.998336 °
				-121.797584 °	-121.799298 °
DWR ID	DWR_NA0016_01_f_2018_86				
Comment Code					
Inspector Comment					
2017 Site ID: SAC 115.9 R Status: Eroding 2017 Field Notes: No observed change. Site History: 2008 - Slippage of cobbles off hard underlying toe material. 2011 - Minor slumping site. 2012 - Failing cobble site, site extended upstream. 2016 - New erosion pockets.  DWR Inspector Comment: Cobble shelf within the water. There is a large section of berm. Does not appear to be actively eroding. Recommend monitoring.

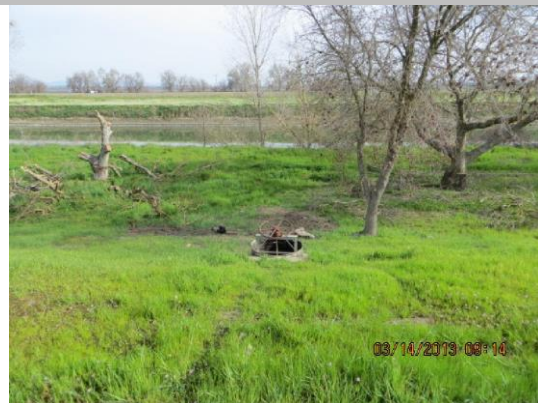
Photo 1 of 3 : UCIP\_SP\_2019\_10261\_17466.jpg

Comment Code					
Inspector Comment					
FS_ID:10261 DS_ID:20249 EP_NO: 9374 Repair Type: Non-Urgent Crossing Status: Found UCIP Comments: Appears abandoned. Pipe should be properly abandoned. FIELD_STRUCT_DESC: 1 of 4: 36-inch corrugated metal irrigation pipe through the levee, 20 feet below the crown. One corrugated metal cutoff wall installed by the United States Army Corp of Engineers, 1955. Slide gate inside a 36-inch corrugated metal riser unit on the waterside (WS) slope. Pump on the WS bank. Concrete standpipe on the landside (LS) toe. (Automatic Board Order (ABO) issued as Permit No. 9374, 1974 - Richard H. Moore). [Additional Reference(s): USACE Sacramento O&M Manual 130, May 1960 (HLM 24.03)]. FS Date: 3/14/2013

36-inch cmp riser on WS slope with slide gate.

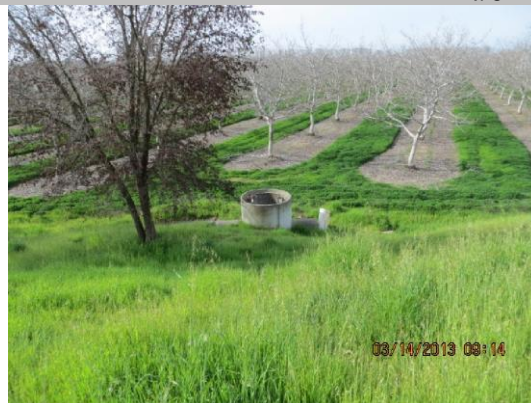
Photo 2 of 3 : UCIP\_SP\_2019\_10261\_17465.jpg

Item	DWR UCIP Field Study			38.998247 °		38.998247 °
				-121.800236 °		-121.800236 °
DWR ID	20249					
Comment Code						
Inspector Comment						
FS_ID:10261 DS_ID:20249 EP_NO: 9374 Repair Type: Non-Urgent Crossing Status: Found UCIP Comments: Appears abandoned. Pipe should be properly abandoned. FIELD_STRUCT_DESC: 1 of 4: 36-inch corrugated metal irrigation pipe through the levee, 20 feet below the crown. One corrugated metal cutoff wall installed by the United States Army Corp of Engineers, 1955. Slide gate inside a 36-inch corrugated metal riser unit on the waterside (WS) slope. Pump on the WS bank. Concrete standpipe on the landside (LS) toe. (Automatic Board Order (ABO) issued as Permit No. 9374, 1974 - Richard H. Moore). [Additional Reference(s): USACE Sacramento O&M Manual 130, May 1960 (HLM 24.03)]. FS Date: 3/14/2013

Concrete distribution riser on LS toe.

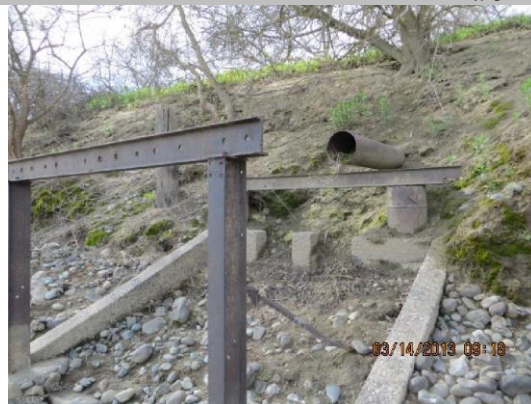
Photo 3 of 3 : UCIP\_SP\_2019\_10261\_17464.jpg

abandoned pump platform on Rivers edge.

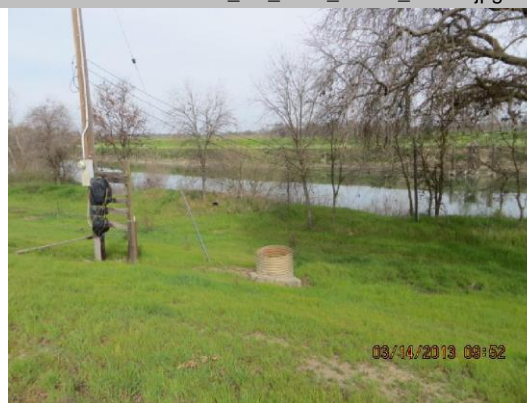
Photo 1 of 2 : UCIP\_SP\_2019\_10265\_17486.jpg

Comment Code					
Inspector Comment					
FS_ID:10265 DS_ID:20251 EP_NO: 9328 Repair Type: Non-Urgent Crossing Status: Found UCIP Comments: Appears abandoned. Needs to be abandoned properly. FIELD_STRUCT_DESC: 24-inch corrugated metal irrigation pipe through the levee, 20 feet below the crown. Slide gate inside a 36-inch corrugated metal riser unit on the waterside (WS) slope. 7-foot by 9-foot distribution box at the toe of the landside (LS) slope. (Automatic Board Order (ABO) issued as Permit No. 9328, 1974 - Wayne A. Hine). [Additional Reference(s): DWR Levee Log, 2006. USACE Sacramento O&M Manual 130, May 1960 (HLM 25.02)]. FS Date: 3/14/2013

Slide gate in 36-inch CMP riser on WS slope.

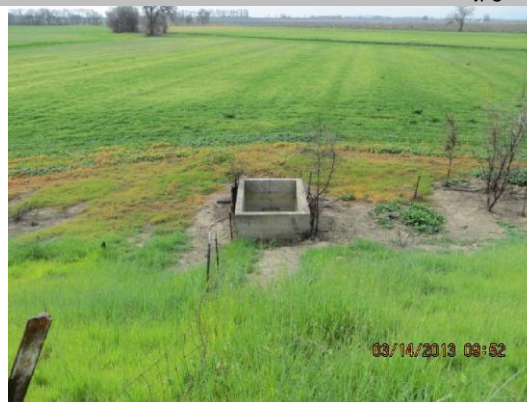
Photo 2 of 2 : UCIP\_SP\_2019\_10265\_17485.jpg

7-foot by 9-foot distribution box at LS toe.

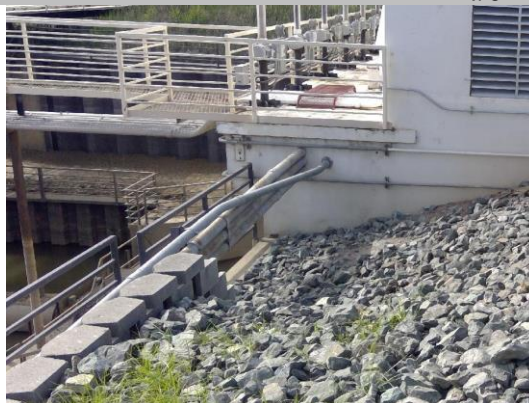
Photo 1 of 3 : UCIP\_SP\_2019\_53973\_79179.jpg

LM Start	25.58	Rating **	M	Issue No.	1578
LM End	25.58	Issue Type +	En	Location *	
Category	Supplemental			GPS Latitude/Longitude	
				Start	End
Item	DWR UCIP Field Study			39.012562 °	39.012562 °
				-121.827853 °	-121.827853 °
DWR ID	22960				
Comment Code					
Inspector Comment					
FS_ID:53973					
DS_ID:22960					
EP_NO: N/A					
Repair Type: Non-Urgent					
Crossing Status: Found					
UCIP Comments: 05/06/2019 Crossing is in good condition. (DWR					
UCIP - O.Yakimov)					
FIELD_STRUCT_DESC: 1 of 4: 4-inch galvanized iron electrical conduit					
through the levee, 3 feet below the crown. Pipe runs from an electric					
vault on the landside (LS) shoulder to a building on the waterside (WS)					
shoulder.					
FS Date: 5/6/2019 2:44:19 PM

Closer view of conduits coming out of building

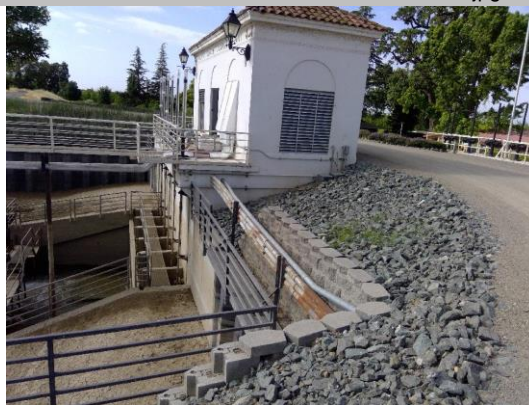
Photo 2 of 3 : UCIP\_SP\_2019\_53973\_79180.jpg

Four conduits crossing the levee. View of WS slope

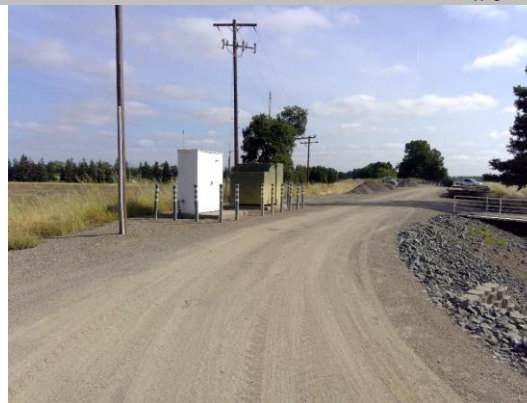
Photo 3 of 3 : UCIP\_SP\_2019\_53973\_79182.jpg

LM Start	25.58	Rating **	M	Issue No.	1578 (cont)	
LM End	25.58	Issue Type +	En	Location *		
Category	Supplemental			GPS Latitude/Longitude		
				Start	End	
Item	DWR UCIP Field Study			39.012562 °	39.012562 °	
				-121.827853 °	-121.827853 °	
DWR ID	22960					
Comment Code						
Inspector Comment						
FS_ID:53973						
DS_ID:22960						
EP_NO: N/A						
Repair Type: Non-Urgent						
Crossing Status: Found						
UCIP Comments: 05/06/2019 Crossing is in good condition. (DWR						
UCIP - O.Yakimov)						
FIELD_STRUCT_DESC: 1 of 4: 4-inch galvanized iron electrical conduit						
through the levee, 3 feet below the crown. Pipe runs from an electric						
vault on the landside (LS) shoulder to a building on the waterside (WS)						
shoulder.						
FS Date: 5/6/2019 2:44:19 PM

Top of Levee with electrical vaults on LS shoulder

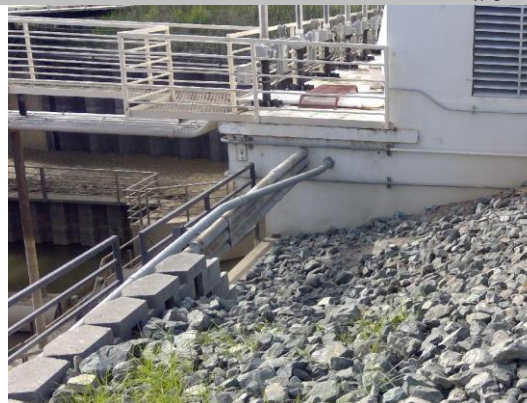
Photo 1 of 3 : UCIP\_SP\_2019\_53974\_79183.jpg

LM Start	25.58	Rating **	M	Issue No.	1579
LM End	25.58	Issue Type +	En	Location *	
Category	Supplemental			GPS Latitude/Longitude	
				Start	End
Item	DWR UCIP Field Study			39.012562 °	39.012562 °
				-121.827853 °	-121.827853 °
DWR ID	22961				
Comment Code					
Inspector Comment					
FS_ID:53974 DS_ID:22961 EP_NO: N/A Repair Type: Non-Urgent Crossing Status: Found UCIP Comments: 05/06/2019 Crossing is in good condition. (DWR UCIP - O.Yakimov) FIELD_STRUCT_DESC: 2 of 4: 4-inch galvanized iron electrical conduit through the levee, 3.4 feet below the crown. Pipe runs from an electric vault on the landside (LS) shoulder to a building on the waterside (WS) shoulder. FS Date: 5/6/2019 2:56:10 PM

Closer view of conduits coming out of building

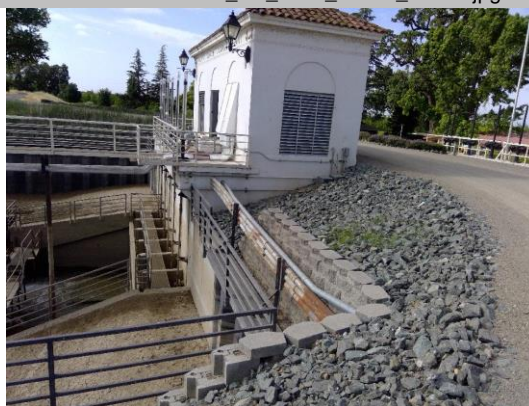
Photo 2 of 3 : UCIP\_SP\_2019\_53974\_79184.jpg

LM Start	25.58	Rating **	M	Issue No.	1579 (cont)	
LM End	25.58	Issue Type +	En	Location *		
Category	Supplemental			GPS Latitude/Longitude		
				Start	End	
Item	DWR UCIP Field Study			39.012562 °	39.012562 °	
				-121.827853 °	-121.827853 °	
DWR ID	22961					
Comment Code						
Inspector Comment						
FS_ID:53974						
DS_ID:22961						
EP_NO: N/A						
Repair Type: Non-Urgent						
Crossing Status: Found						
UCIP Comments: 05/06/2019 Crossing is in good condition. (DWR						
UCIP - O.Yakimov)						
FIELD_STRUCT_DESC: 2 of 4: 4-inch galvanized iron electrical conduit						
through the levee, 3.4 feet below the crown. Pipe runs from an electric						
vault on the landside (LS) shoulder to a building on the waterside (WS)						
shoulder.						
FS Date: 5/6/2019 2:56:10 PM

Four conduits crossing the levee. View of WS slope

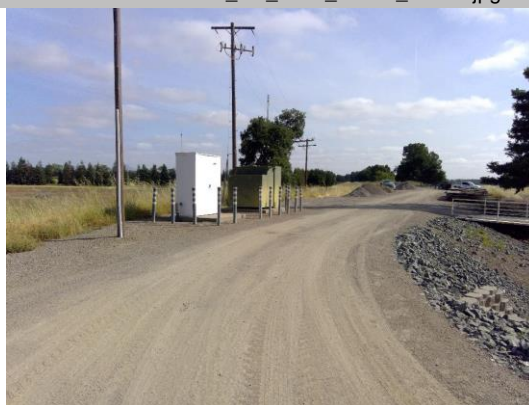
Photo 3 of 3 : UCIP\_SP\_2019\_53974\_79186.jpg

Top of Levee with electrical vaults on LS shoulder

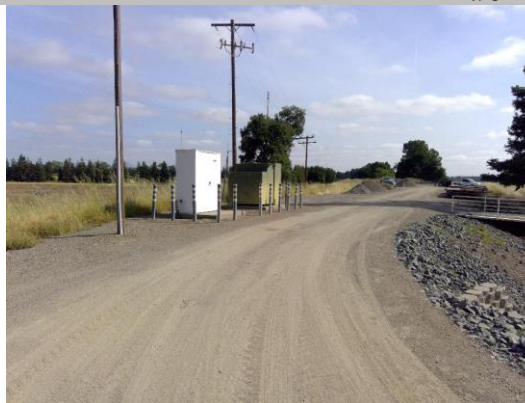
Photo 3 of 3 : UCIP\_SP\_2019\_53975\_79190.jpg

LM Start	25.58	Rating **	M	Issue No.	1580 (cont)	
LM End	25.58	Issue Type +	En	Location *		
Category	Supplemental			GPS Latitude/Longitude		
				Start	End	
Item	DWR UCIP Field Study			39.012562 °	39.012562 °	
				-121.827853 °	-121.827853 °	
DWR ID	22962					
Comment Code						
Inspector Comment						
FS_ID:53975 DS_ID:22962 EP_NO: N/A Repair Type: Non-Urgent Crossing Status: Found UCIP Comments: 05/06/2019 Crossing is in good condition. (DWR UCIP - O.Yakimov) FIELD_STRUCT_DESC: 3 of 4: 4-inch galvanized iron electrical conduit through the levee, 3.8 feet below the crown. Pipe runs from an electric vault on the landside (LS) shoulder to a building on the waterside (WS) shoulder. FS Date: 5/6/2019 2:57:32 PM

Top of Levee with electrical vaults on LS shoulder

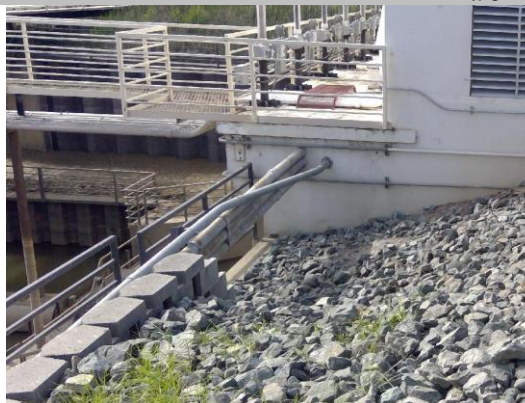
Photo 1 of 3 : UCIP\_SP\_2019\_53976\_79191.jpg

LM Start	25.58	Rating **	M	Issue No.	1581
LM End	25.58	Issue Type +	En	Location *	
Category	Supplemental			GPS Latitude/Longitude	
				Start	End
Item	DWR UCIP Field Study			39.012562 °	39.012562 °
				-121.827853 °	-121.827853 °
DWR ID	22963				
Comment Code					
Inspector Comment					
FS_ID:53976 DS_ID:22963 EP_NO: N/A Repair Type: Non-Urgent Crossing Status: Found UCIP Comments: 05/06/2019 Crossing is in good condition. (DWR UCIP - O.Yakimov) FIELD_STRUCT_DESC: 4 of 4: 4-inch galvanized iron electrical conduit through the levee, 4.2 feet below the crown. Pipe runs from an electric vault on the landside (LS) shoulder to a building on the waterside (WS) shoulder. FS Date: 5/6/2019 2:58:34 PM

Closer view of conduits coming out of building

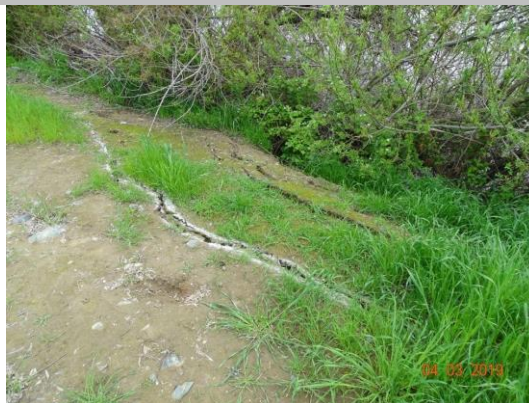
Photo 2 of 2 : SP\_2019\_NA0016\_435\_81\_20190404\_00213.jpg

LM Start	25.76	Rating **	A/W	Issue No.	81 (cont)	
LM End	25.76	Issue Type +	Ma	Location *	WS	
Category	Earthen Levee			GPS Latitude/Longitude		
				Start		End
Item	Cracking			39.014725 °		39.014725 °
				-121.826050 °		-121.826050 °
DWR ID	DWR_NA0016_01_s_2019_81					
Comment Code						
CR1 : Monitor and have inspected by geotechnical engineer.						
Inspector Comment						
50' cracking section on waterside bench. LMA has staked crown and painted over the cracks. Recommend monitoring.

View of cracking on the waterside berm. Spring 2019.

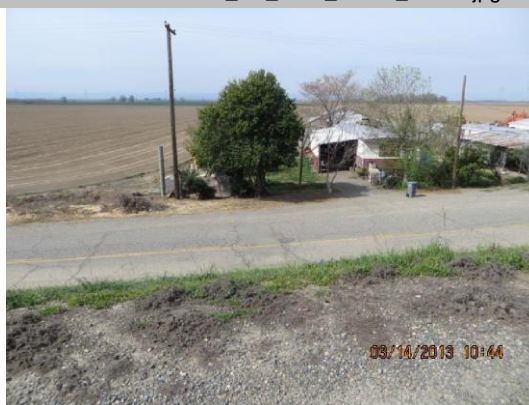
Photo 1 of 3 : UCIP\_SP\_2019\_53977\_17532.jpg

Comment Code					
Inspector Comment					
FS_ID:53977 DS_ID:20253 EP_NO: 9136 Repair Type: Non-Urgent Crossing Status: Found UCIP Comments: 05/06/2019 Unable to see pipe outlet ar riverbank due to vegetation. Levee is in good condition at the crossing. (DWR UCIP - O.Yakimov) Pipe appears to be abandoned. Pipe needs to be abandoned properly. FIELD_STRUCT_DESC: *ABANDONED* 18-inch coated steel drainage pipe through the levee, 3 feet below the crown. Steel cutoff wall at the centerline. Air release valve on the waterside (WS) shoulder. Slide gate inside a 72-inch diameter corrugated metal riser unit on the landside (LS) toe. (Permit No. 9136, 1973 - Durst Brothers). [Additional Reference(s): DWR Levee Log, 2006]. FS Date: 5/6/2019 3:43:56 PM

72-inch CMP riser on LS toe under JP next to tree.

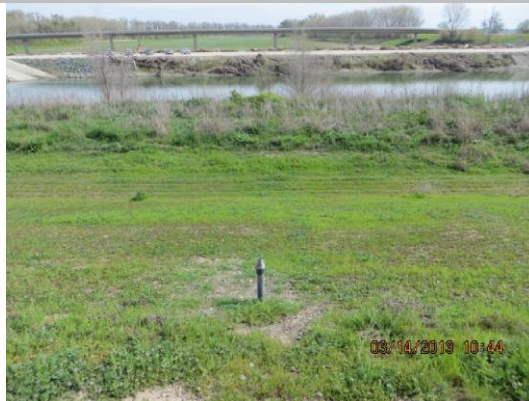
Photo 2 of 3 : UCIP\_SP\_2019\_53977\_17531.jpg

Comment Code					
Inspector Comment					
FS_ID:53977 DS_ID:20253 EP_NO: 9136 Repair Type: Non-Urgent Crossing Status: Found UCIP Comments: 05/06/2019 Unable to see pipe outlet ar riverbank due to vegetation. Levee is in good condition at the crossing. (DWR UCIP - O.Yakimov) Pipe appears to be abandoned. Pipe needs to be abandoned properly. FIELD_STRUCT_DESC: *ABANDONED* 18-inch coated steel drainage pipe through the levee, 3 feet below the crown. Steel cutoff wall at the centerline. Air release valve on the waterside (WS) shoulder. Slide gate inside a 72-inch diameter corrugated metal riser unit on the landside (LS) toe. (Permit No. 9136, 1973 - Durst Brothers). [Additional Reference(s): DWR Levee Log, 2006]. FS Date: 5/6/2019 3:43:56 PM

Air release valve on WS shoulder.

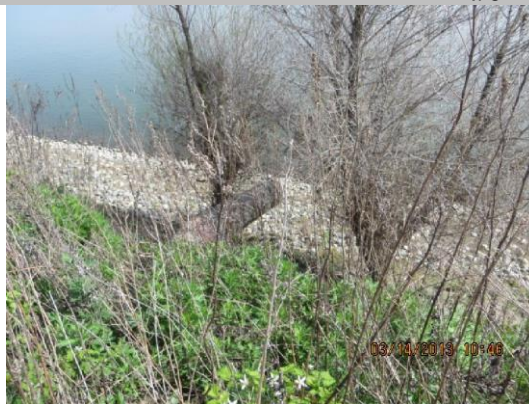
Photo 3 of 3 : UCIP\_SP\_2019\_53977\_17534.jpg

Pipe at Rivers edge.

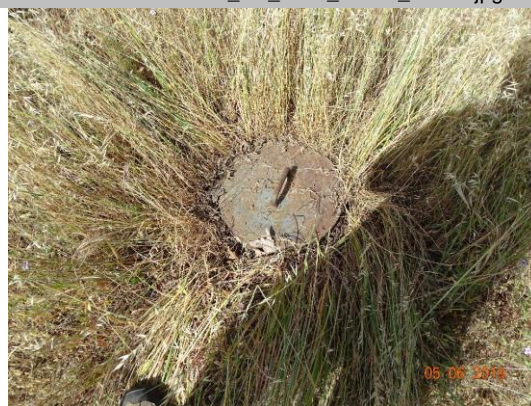
Photo 1 of 3 : UCIP\_SP\_2019\_53978\_79198.jpg

Comment Code						
Inspector Comment						
FS_ID:53978 DS_ID:20255 EP_NO: 4786 Repair Type: Non-Urgent Crossing Status: Found UCIP Comments: 05/06/2019 Crossing not in use and looks abandoned. Air release valve is silted inside a riser on WS shoulder (DWR UCIP - O.Yakimov) FIELD_STRUCT_DESC: 16-inch steel drainage pipe through the levee, 6.2 feet below the crown. One metal cutoff wall. Gate valve on the landside (LS) end. Siphon breaker on the waterside (WS) slope inside steel riser unit. Flap gate on the WS end. Bank rock revetted. (Permit No. 4786, 1964 - F. Erdman). [Additional Reference(s): DWR Levee Log, 2006]. FS Date: 5/6/2019 4:11:08 PM

View of covered metal riser on WS shoulder

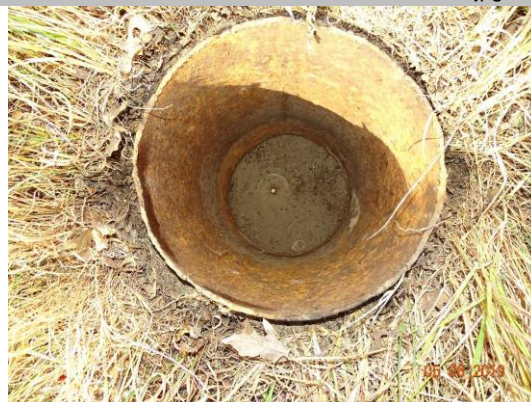
Photo 2 of 3 : UCIP\_SP\_2019\_53978\_79199.jpg

Air valve is silted inside of metal riser

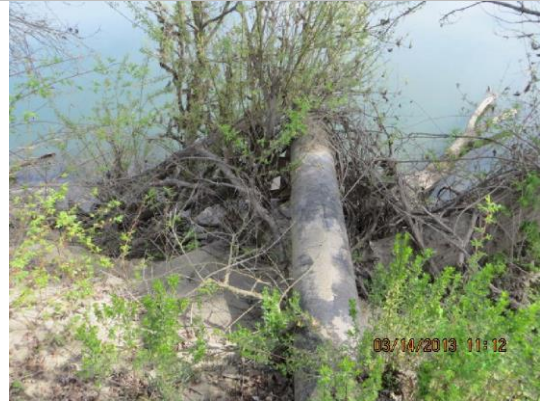
Photo 3 of 3 : UCIP\_SP\_2019\_53978\_17539.jpg

Item	DWR UCIP Field Study			39.029144 °	39.029144 °	
				-121.823774 °	-121.823774 °	
DWR ID	20255					
Comment Code						
Inspector Comment						
FS_ID:53978 DS_ID:20255 EP_NO: 4786 Repair Type: Non-Urgent Crossing Status: Found UCIP Comments: 05/06/2019 Crossing not in use and looks abandoned. Air release valve is silted inside a riser on WS shoulder (DWR UCIP - O.Yakimov) FIELD_STRUCT_DESC: 16-inch steel drainage pipe through the levee, 6.2 feet below the crown. One metal cutoff wall. Gate valve on the landside (LS) end. Siphon breaker on the waterside (WS) slope inside steel riser unit. Flap gate on the WS end. Bank rock revetted. (Permit No. 4786, 1964 - F. Erdman). [Additional Reference(s): DWR Levee Log, 2006]. FS Date: 5/6/2019 4:11:08 PM

Pipe at rivers edge.

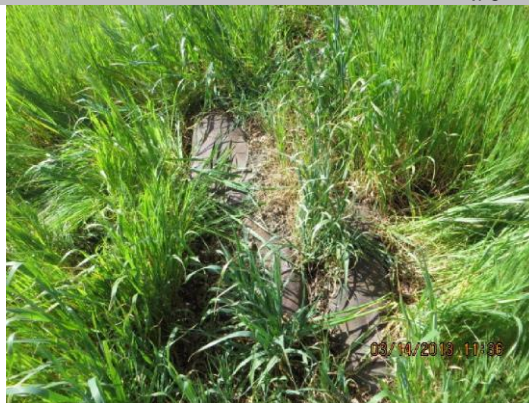
Photo 1 of 2 : UCIP\_SP\_2019\_53981\_17545.jpg

LM Start	27.46	Rating **	M	Issue No.	1585	
LM End	27.46	Issue Type +	En	Location *		
Category	Supplemental			GPS Latitude/Longitude		
				Start		End
Item	DWR UCIP Field Study			39.033814 °		39.033814 °
				-121.833158 °		-121.833158 °
DWR ID	20416					
Comment Code						
Inspector Comment						
FS_ID:53981 DS_ID:20416 EP_NO: N/A Repair Type: Non-Urgent Crossing Status: Indicator Found UCIP Comments: 05/06/2019 Crossing not found. A candidate for electromagnetic survey.(DWR UCIP - O.Yakimov) Appears this pipe is abandoned and visible on WS slope in pieces. Need to verify proper abandonment. FIELD_STRUCT_DESC: *ABANDONED* 24-inch pipe of an unknown type and material through the levee, 6.2 feet below the crown. Pipe debris on the waterside (WS) slope. [Additional Reference(s): USACE Sacramento O&M Manual 131, May 1960 (HLM 27.79)]. FS Date: 5/6/2019 9:13:36 AM

Pipe debris on WS slope.

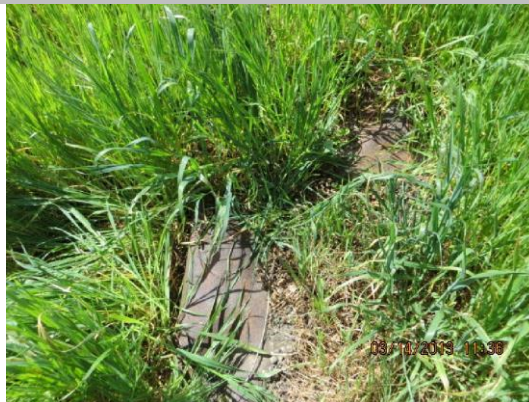
Photo 2 of 2 : UCIP\_SP\_2019\_53981\_17544.jpg

Pipe debris on WS slope.

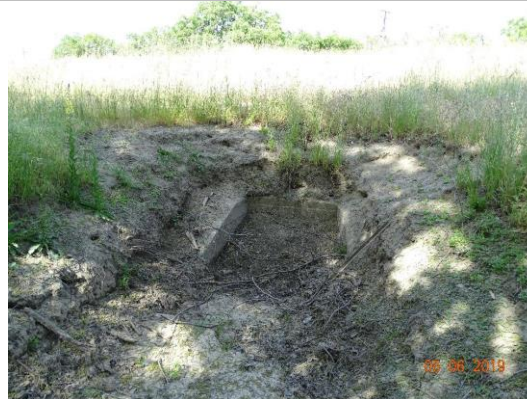
Photo 1 of 3 : UCIP\_SP\_2019\_53982\_79209.jpg

Comment Code					
Inspector Comment					
FS_ID:53982 DS_ID:20257 EP_NO: 9355 Repair Type: Non-Urgent Crossing Status: Found UCIP Comments: 05/06/2019 Inlet and outlet gates are silted. Missing handwheel on gate valve at LS toe. (DWR UCIP - O.Yakimov) Pipe needs to be properly abandoned. FIELD_STRUCT_DESC: *ABANDONED* 24-inch steel drainage pipe through the levee, 14 feet below the crown. Slide gate on the waterside (WS) end. Gate valve on the landside (LS) end. (24-inch pipe [HLM 27.89] authorized under Automatic Board Order (ABO) issued as Permit No. 9355, 1974 - Alvin Gustafson). [Additional Reference(s): DWR Levee Log, 2006. USACE Sacramento O&M Manual 131, May 1960 (HLM 27.89)]. FS Date: 5/6/2019 9:24:06 AM

Slide gate silted on WS end

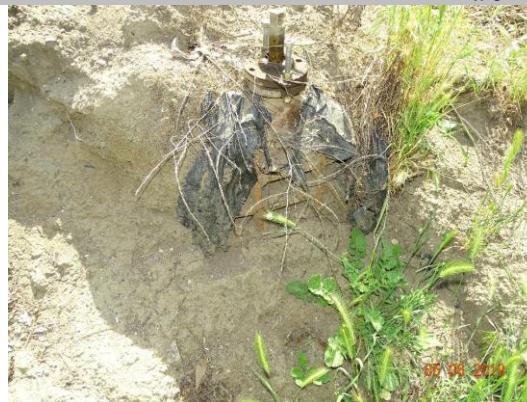
Photo 2 of 3 : UCIP\_SP\_2019\_53982\_79210.jpg

Gate valve silted at LS toe. Missing handwheel

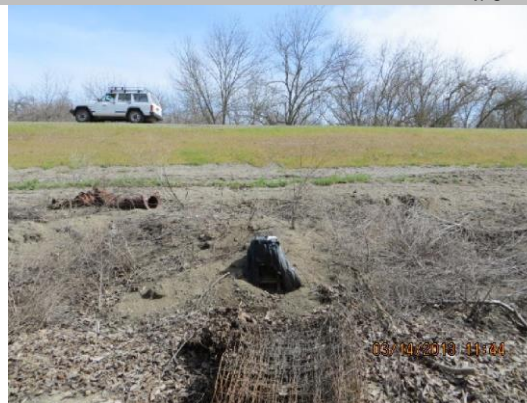
Photo 3 of 3 : UCIP\_SP\_2019\_53982\_17548.jpg

Item	DWR UCIP LMA Responsibility			39.034870 °	39.034870 °	
				-121.833501 °	-121.833501 °	
DWR ID	20257					
Comment Code						
Inspector Comment						
FS_ID:53982 DS_ID:20257 EP_NO: 9355 Repair Type: Non-Urgent Crossing Status: Found UCIP Comments: 05/06/2019 Inlet and outlet gates are silted. Missing handwheel on gate valve at LS toe. (DWR UCIP - O.Yakimov) Pipe needs to be properly abandoned. FIELD_STRUCT_DESC: *ABANDONED* 24-inch steel drainage pipe through the levee, 14 feet below the crown. Slide gate on the waterside (WS) end. Gate valve on the landside (LS) end. (24-inch pipe [HLM 27.89] authorized under Automatic Board Order (ABO) issued as Permit No. 9355, 1974 - Alvin Gustafson). [Additional Reference(s): DWR Levee Log, 2006. USACE Sacramento O&M Manual 131, May 1960 (HLM 27.89)]. FS Date: 5/6/2019 9:24:06 AM

Gate valve buried on LS toe

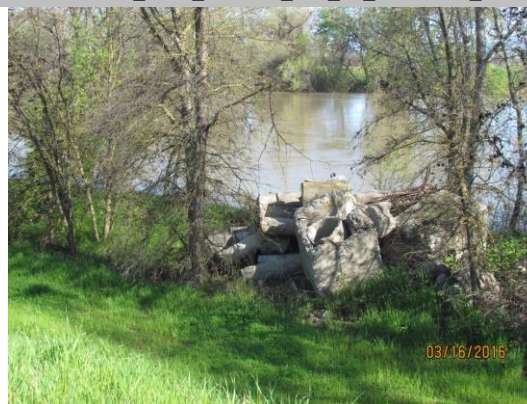
Photo 1 of 1 : SP\_2019\_NA0016\_435\_59\_20190304\_00018.jpg

LM Start	28.02	Rating **	M	Issue No.	59
LM End	28.02	Issue Type +	En	Location *	WS
Category	Earthen Levee			GPS Latitude/Longitude	
				Start	End
Item	Encroachments			39.040750 °	39.040750 °
				-121.835299 °	-121.835299 °
DWR ID	DWR_NA0016_01_s_2012_59				
Comment Code					
DE : Debris					
Inspector Comment					
There are piles of concrete on the waterside berm.

View of the pile of concrete on the waterward berm of the levee. Spring 2016.

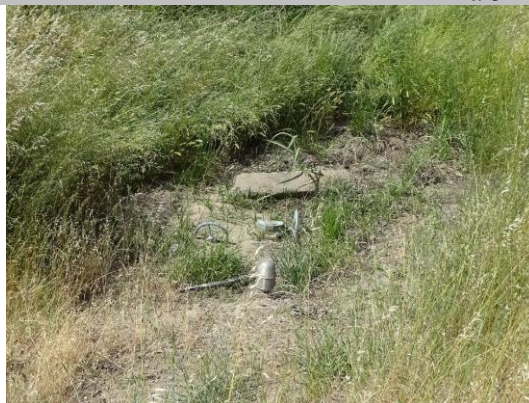
Photo 1 of 3 : UCIP\_SP\_2019\_53983\_79212.jpg

Comment Code					
Inspector Comment					
FS_ID:53983 DS_ID:20258 EP_NO: 9367 Repair Type: Non-Urgent Crossing Status: Found UCIP Comments: 05/06/2019 Closure devices located at LS toe are buried with mud that limits their operation. (DWR UCIP - O.Yakimov) FIELD_STRUCT_DESC: 14-inch irrigation pipe of an unknown material through the levee, 7.5 feet below the crown. Pump in pump house on the waterside (WS) bank. Siphon breaker inside a 24-inch corrugated metal riser unit on the landside (LS) slope. Pole on the WS shoulder. (Automatic Board Order (ABO) issued as Permit No. 9367, 1974 - Elna Schohr, Inc.). [Additional Reference(s): DWR Levee Log, 2006. USACE Sacramento O&M Manual 131, May 1960 (HLM 28.41)]. FS Date: 5/6/2019 11:22:51 AM

Closure devices at LS toe

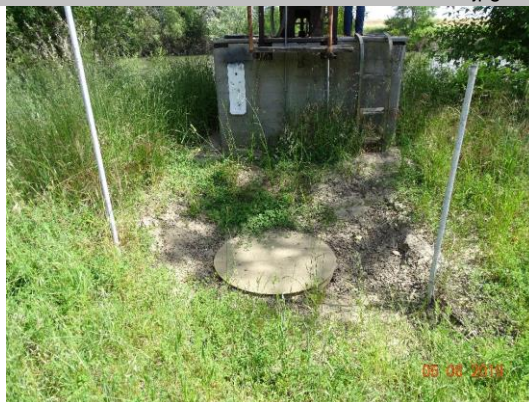
Photo 2 of 3 : UCIP\_SP\_2019\_53983\_79213.jpg

Pumping vault at riverbank

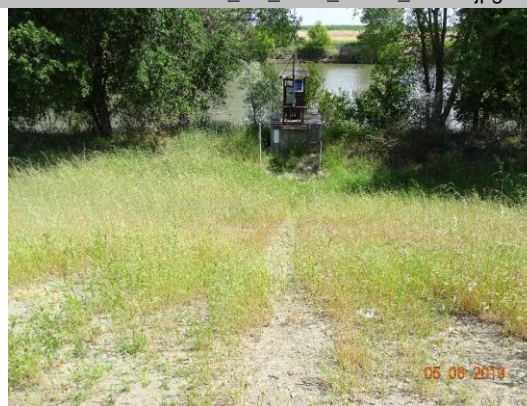
Photo 3 of 3 : UCIP\_SP\_2019\_53983\_79215.jpg

Comment Code					
Inspector Comment					
FS_ID:53983 DS_ID:20258 EP_NO: 9367 Repair Type: Non-Urgent Crossing Status: Found UCIP Comments: 05/06/2019 Closure devices located at LS toe are buried with mud that limits their operation. (DWR UCIP - O.Yakimov) FIELD_STRUCT_DESC: 14-inch irrigation pipe of an unknown material through the levee, 7.5 feet below the crown. Pump in pump house on the waterside (WS) bank. Siphon breaker inside a 24-inch corrugated metal riser unit on the landside (LS) slope. Pole on the WS shoulder. (Automatic Board Order (ABO) issued as Permit No. 9367, 1974 - Elna Schohr, Inc.). [Additional Reference(s): DWR Levee Log, 2006. USACE Sacramento O&M Manual 131, May 1960 (HLM 28.41)]. FS Date: 5/6/2019 11:22:51 AM

View of pump on WS berm

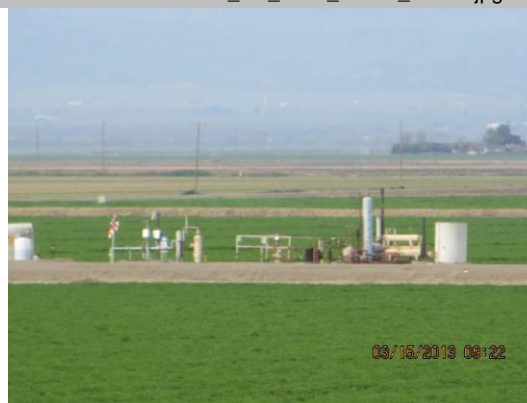
Photo 1 of 1 : UCIP\_SP\_2019\_53984\_17563.jpg

Comment Code						
Inspector Comment						
FS_ID:53984 DS_ID:20319 EP_NO: 16632 Repair Type: Non-Urgent Crossing Status: Indicator Found UCIP Comments: 05/06/2019 No gas line markers observed. (DWR UCIP - O.Yakimov)09/01/2016 - No markers on levee. no condition in permit for markers. Pipe is well underneath the levee prism with minimum clearance under the river of 35 feet per permit drawings. (T. Hatch/UCIP) 03/15/2013 No gasline markers on either side of levee. (W. Wylie/UCIP) FIELD_STRUCT_DESC: 4-inch welded steel natural gas pipeline through the levee, 62 feet below the crown. Crosses under both levees and the Sacramento River channel with a minimum clearance of 35 feet. Gas well visible approximately 1,500 feet west of the levee on the landside (LS). (Permit No. 16632, 1997 - Slawson Exploration Company, Inc./AA Production Services, Inc.). FS Date: 5/6/2019 12:47:47 PM

gas well 1500-feet west of this location.

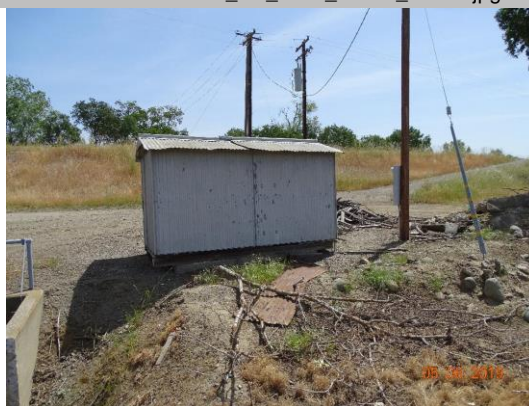
Photo 3 of 3 : UCIP\_SP\_2019\_53985\_79219.jpg

Item	DWR UCIP LMA Responsibility			39.048281 °		39.048281 °
				-121.841084 °		-121.841084 °
DWR ID	20341					
Comment Code						
Inspector Comment						
FS_ID:53985						
DS_ID:20341						
EP_NO: 9358						
Repair Type: No Action Needed						
Crossing Status: Found						
UCIP Comments: 05/06/2019 Crossing is in good condition. (DWR UCIP - O.Yakimov)						
FIELD_STRUCT_DESC: 16-inch steel drainage pipe through the levee, 8.5 feet below the crown. Siphon breaker inside a 24-inch corrugated metal riser unit on the waterside (WS) slope. Pump inside pump house on the landside (LS). Overhead power line crosses the levee. Pole on the LS shoulder. (one 12-inch, one 16-inch, and one 24-inch pipes [HLM 29.02] authorized under Automatic Board Order (ABO) issued as Permit No. 9358, 1974 - Crocker National Bank (Trustee)). [Additional Reference(s): DWR Levee Log, 2006. USACE Sacramento O&M Manual 131, May 1960 (HLM 29.02)].

Pumphouse and sump on LS looking from landside

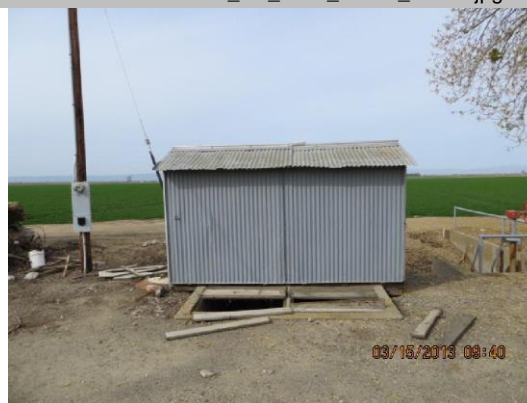
Photo 3 of 3 : UCIP\_SP\_2019\_53986\_17569.jpg

Item	DWR UCIP LMA Responsibility			39.048295 °	39.048295 °	
				-121.841088 °	-121.841088 °	
DWR ID	20259					
Comment Code						
Inspector Comment						
FS_ID:53986 DS_ID:20259 EP_NO: 9358 Repair Type: No Action Needed Crossing Status: Found UCIP Comments: 05/06/2019 Crossing is in good condition. (DWR UCIP - O.Yakimov) FIELD_STRUCT_DESC: 10-inch steel drainage pipe through the levee, 8 feet below the crown. Siphon breaker in a 24-inch corrugated metal riser on the waterside (WS) slope. Slide gate at base of pump house on landside (LS) toe. Pump over sump at pump house on LS toe. Overhead power line crosses the levee. Pole on the LS shoulder. (one 12-inch, one 16-inch, and one 24-inch pipes [HLM 29.02] authorized under Automatic Board Order (ABO) issued as Permit No. 9358, 1974 - Crocker National Bank (Trustee)). [Additional Reference(s): DWR Levee Log, 2006. USACE Sacramento O&M Manual 131, May 1960 (HLM 29.02)]. FS Date: 5/6/2019 2:23:55 PM

Pumphouse over sump on LS toe.

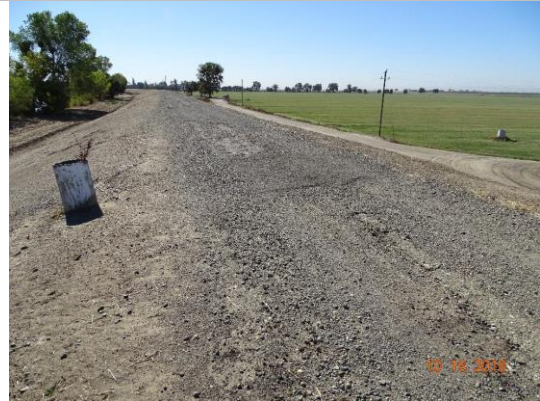
Photo 2 of 3 : UCIP\_SP\_2019\_53988\_78168.jpg

Comment Code					
Inspector Comment					
FS_ID:53988 DS_ID:20311 EP_NO: 12609 Repair Type: Urgent Crossing Status: Found UCIP Comments: 05/06/2019 No changes from last inspection. Pipe on riverbank is under water. (DWR UCIP - O.Yakimov)10/16/2018 Water level is low enough to see that flap gate on WS end is missing. In addition, pipe has corroded through around flap gate frame. Unable to locate pipe inlet on LS. Crossing must be abandoned properly. Recommend internal pipe inspection to determine pipe integrity through levee. (O.Yakimov - DWR)09/23/2016 - pipe outlet still submerged, but visible enough to determine that flap gate is still missing. Appurtenances on the LS of the levee do not appear to be associated with this pipe. There is no visible location for collection of drainage water to go through the outfall. As a result, it does not appear that this pipe is in use. (T. Hatch/UCIP) 09/01/201 - pipe outlet was submerged at time of inspection. Unable to view if flap gate had been replaced. Otherwise, conditions do not appear to be significantly different from previous inspection. (T. Hatch/UCIP) 03/15/201- Flap gate missing from waterward end of pipe. (W. Wylie/UCIP) FIELD_STRUCT_DESC: 24-inch steel outfall drainage pipe through the levee, 4.1 feet below the crown. Siphon breaker inside an 18-inch concrete riser unit on the waterside (WS) shoulder. Flap gate on the WS toe. Rock protection along the riverbank at the WS toe. (Permit No. 12609, 1978 - Jack E. Gross). [Additional Reference(s): DWR Levee Log, 2006]. FS Date: 5/6/2019 3:02:33 PM

View of levee crown at crossing.

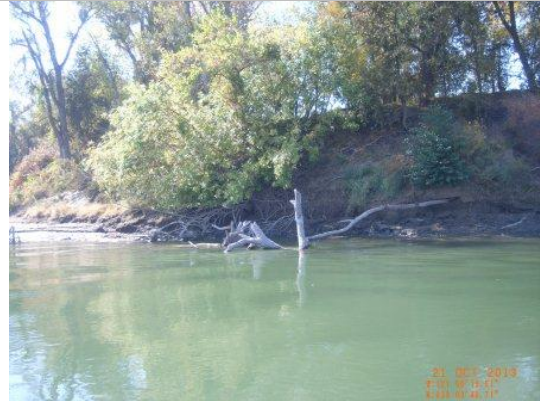
Photo 1 of 1 : SP\_2019\_NA0016\_435\_89\_20190304\_00024.jpg

LM Start	29.69	Rating **	A/W	Issue No.	89
LM End	29.73	Issue Type +	Ma	Location *	WS
Category	Supplemental			GPS Latitude/Longitude	
				Start	End
Item	2017 USACE Erosion Survey, DRAFT			39.063209 °	39.063997 °
				-121.838927 °	-121.839335 °
DWR ID	DWR_NA0016_01_f_2018_89				
Comment Code					
Inspector Comment					
2017 Site ID: SAC 122.0 R					
Status: Eroding					
2017 Field Notes: Minor new erosion at toe.					
Site History: 1997 - Mass failure of the lower cohesive bank and toe.					
2000 - Still eroding, steeply dipping foresets in the toe are falling off.					
2010 - Some new erosion and some new deposition. Eddy current off the upstream rock. 2011 - Still plenty of berm left. 2016 - Minor new erosion.

USACE 2013 Photo #1

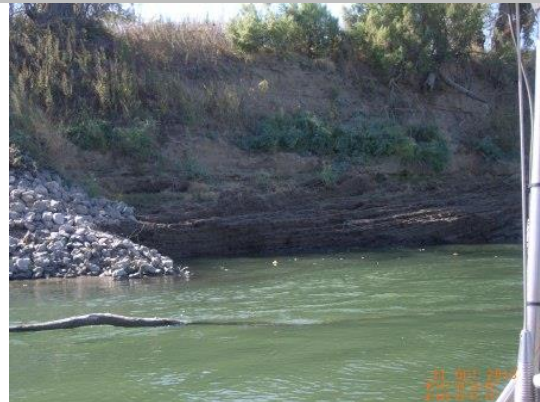
Photo 1 of 1 : SP\_2019\_NA0016\_435\_91\_20190304\_00026.jpg

Comment Code					
Inspector Comment					
2017 Site ID: SAC 122.3 R					
Status: Eroding					
2017 Field Notes: Fresh slumping erosion at toe.					
Site History: 2002 - Upstream end has recent slope failure and exposure of tree roots. 2003 - Some new minor slope erosion with new snags on the bank. 2004 - Appears a little worse. 2005 - Scallop in bank at the upstream end looks worse. 2009 - Minimal new erosion, Berm width is still large, but one large event or one fallen tree and it could go fast. 2010 - New erosion, bank is nearly all vertical from slumping. Site looks bad. 2011 - Site continues to look bad. 2012 - Minor new erosion. 2015 - Undermining of toe rock. 2016 - Site extended upstream, new erosion and exposed tree roots.					
DWR Inspector Comment: No erosion within the prism and vegetation appears to be stabilizing the bank. Recommend monitoring.

USACE 2013 Photo #1

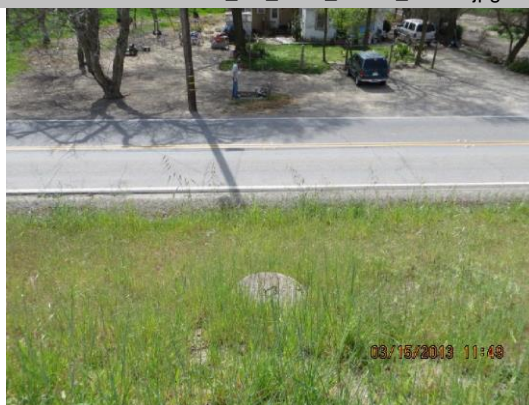
Photo 1 of 2 : UCIP\_SP\_2019\_10364\_17645.jpg

Comment Code					
Inspector Comment					
FS_ID:10364 DS_ID:20304 EP_NO: 9374 Repair Type: Non-Urgent Crossing Status: Found UCIP Comments: Need to verify type of abandonment FIELD_STRUCT_DESC: *ABANDONED* 2 of 4: 4-inch irrigation pipe of an unknown material through the levee, 6.5 feet below the crown. Gate valve on the waterside (WS) end. Siphon breaker inside a 24-inch corrugated metal riser unit on the landside (LS) slope. 4-foot by 4-foot concrete distribution box on the south side of Highway 45 at the LS toe. (Automatic Board Order (ABO) issued as Permit No. 9374, 1974 - Richard H. Moore). [Additional Reference(s): DWR Levee Log, 1980. USACE Sacramento O&M Manual 131, May 1960 (HLM 32.68)]. FS Date: 3/15/2013

Siphon Breaker in 25-inch CMP riser on LS slope with 4X4 concrete box off LS toe.

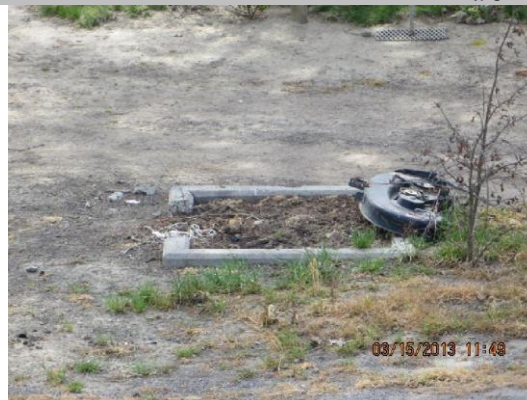
Photo 2 of 2 : UCIP\_SP\_2019\_10364\_17644.jpg

Item	DWR UCIP Field Study			39.069857 °		39.069857 °
				-121.880923 °		-121.880923 °
DWR ID	20304					
Comment Code						
Inspector Comment						
FS_ID:10364 DS_ID:20304 EP_NO: 9374 Repair Type: Non-Urgent Crossing Status: Found UCIP Comments: Need to verify type of abandonment FIELD_STRUCT_DESC: *ABANDONED* 2 of 4: 4-inch irrigation pipe of an unknown material through the levee, 6.5 feet below the crown. Gate valve on the waterside (WS) end. Siphon breaker inside a 24-inch corrugated metal riser unit on the landside (LS) slope. 4-foot by 4-foot concrete distribution box on the south side of Highway 45 at the LS toe. (Automatic Board Order (ABO) issued as Permit No. 9374, 1974 - Richard H. Moore). [Additional Reference(s): DWR Levee Log, 1980. USACE Sacramento O&M Manual 131, May 1960 (HLM 32.68)]. FS Date: 3/15/2013

4X4 concrete box off LS toe.

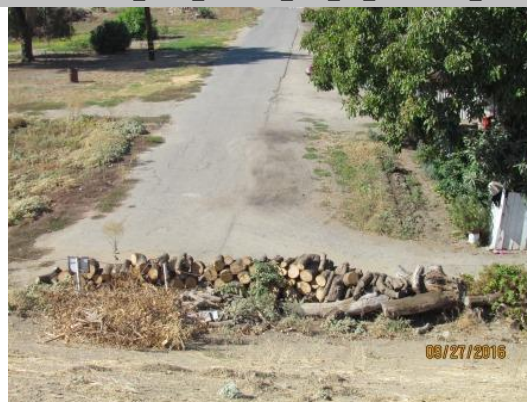
Photo 1 of 1 : SP\_2019\_NA0016\_435\_87\_20190304\_00022.jpg

LM Start	32.95	Rating **	M	Issue No.	87
LM End	32.95	Issue Type +	En	Location *	LS
Category	Earthen Levee			GPS Latitude/Longitude	
				Start	End
Item	Encroachments			39.074125 °	39.074125 °
				-121.891836 °	-121.891836 °
DWR ID	DWR_NA0016_01_f_2016_87				
Comment Code					
FW : Firewood					
Inspector Comment					
Firewood is located within 10 feet of levee toe on the landside.

View of firewood on landside levee toe. Fall 2016 inspection.

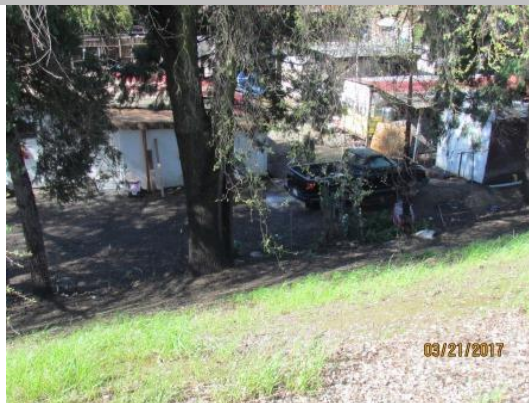
Photo 1 of 1 : SP\_2019\_NA0016\_435\_43\_20190304\_00015.jpg

LM Start	32.97	Rating **	M	Issue No.	43
LM End	32.97	Issue Type +	En	Location *	LS
Category	Earthen Levee			GPS Latitude/Longitude	
				Start	End
Item	Encroachments			39.074346 °	39.074346 °
				-121.892048 °	-121.892048 °
DWR ID	DWR_NA0016_01_s_2019_43				
Comment Code					
FE : Fence					
Inspector Comment					
Fence is blocking access on the landside toe.

View of fence along landside levee toe. Spring 2017.

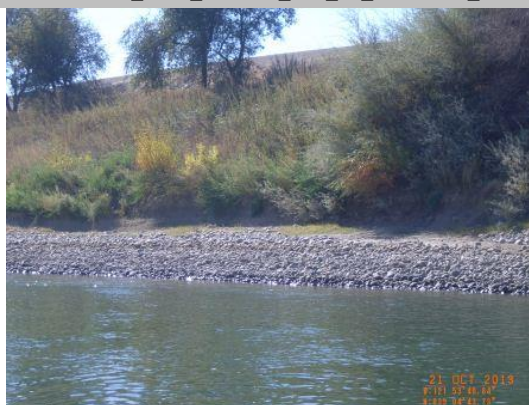
Photo 1 of 1 : SP\_2019\_NA0016\_435\_93\_20190304\_00028.jpg

LM Start	33.29	Rating **	A/W	Issue No.	93
LM End	33.37	Issue Type +	Ma	Location *	WS
Category	Supplemental			GPS Latitude/Longitude	
				Start	End
Item	2017 USACE Erosion Survey, DRAFT			39.078340 °	39.079351 °
				-121.894656 °	-121.895317 °
DWR ID	DWR_NA0016_01_f_2018_93				
Comment Code					
Inspector Comment					
2017 Site ID: SAC 125.6 R					
Status: Eroding					
2017 Field Notes: No observed change.					
Site History: 2008 - Slow erosion of the hard toe. 2010 - Cobble rubble is failing, erosion is into the toe of the levee, with vertical slumping.					
2012 - Site appears to be relatively stable. 2013 - New animal holes.

USACE 2013 Photo #1

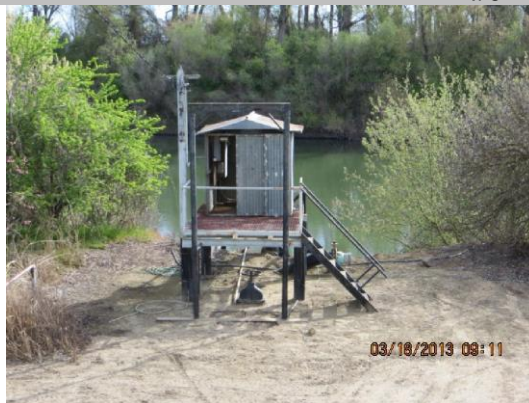
Photo 1 of 3 : UCIP\_SP\_2019\_10403\_17662.jpg

Comment Code					
Inspector Comment					
FS_ID:10403 DS_ID:20268 EP_NO: 9364A Repair Type: Non-Urgent Crossing Status: Found UCIP Comments: Pipe rusted through at concrete distribution box. May be indicator of pipe condition through levee. FIELD_STRUCT_DESC: 1 of 4: 16-inch steel irrigation pipe through the levee, 6.3 feet below the crown. Pump in pump house on the waterside (WS) end. Siphon breaker in a 36-inch steel riser unit on the landside (LS) slope. Discharges into a 5-foot by 9-foot concrete distribution box at the LS toe. (Automatic Board Order (ABO) issued as Permit No. 9364-A, 1974 - Alice Steidlmayer). (Installed by the United States Army Corp of Engineers, 1945). [Additional Reference(s): DWR Levee Log, 2006. USACE Sacramento O&M Manual 131, May 1960 (HLM 34.46)]. FS Date: 3/18/2013

Pump at WS berm.

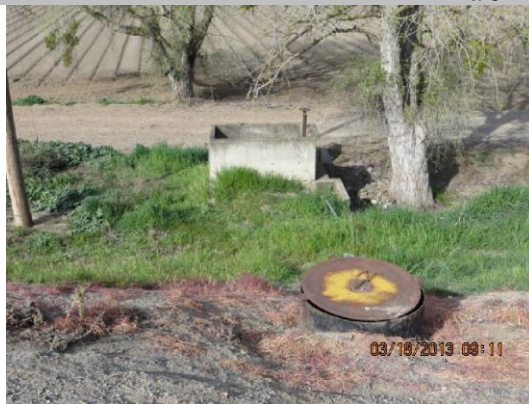
Photo 2 of 3 : UCIP\_SP\_2019\_10403\_17661.jpg

siphon breaker in 36-inch steel riser on LS slope with concrete distribution box on LS toe.

Item	DWR UCIP Field Study			39.087072 °	39.087072 °	
				-121.896464 °	-121.896464 °	
DWR ID	20268					
Comment Code						
Inspector Comment						
FS_ID:10403 DS_ID:20268 EP_NO: 9364A Repair Type: Non-Urgent Crossing Status: Found UCIP Comments: Pipe rusted through at concrete distribution box. May be indicator of pipe condition through levee. FIELD_STRUCT_DESC: 1 of 4: 16-inch steel irrigation pipe through the levee, 6.3 feet below the crown. Pump in pump house on the waterside (WS) end. Siphon breaker in a 36-inch steel riser unit on the landside (LS) slope. Discharges into a 5-foot by 9-foot concrete distribution box at the LS toe. (Automatic Board Order (ABO) issued as Permit No. 9364-A, 1974 - Alice Steidlmayer). (Installed by the United States Army Corp of Engineers, 1945). [Additional Reference(s): DWR Levee Log, 2006. USACE Sacramento O&M Manual 131, May 1960 (HLM 34.46)]. FS Date: 3/18/2013

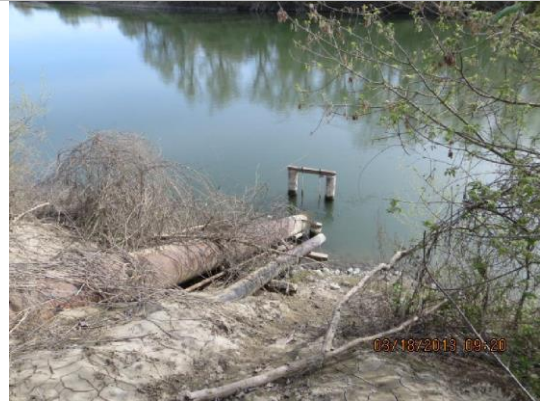
Photo 3 of 3 : UCIP\_SP\_2019\_10403\_17660.jpg

Pipe at waters edge.

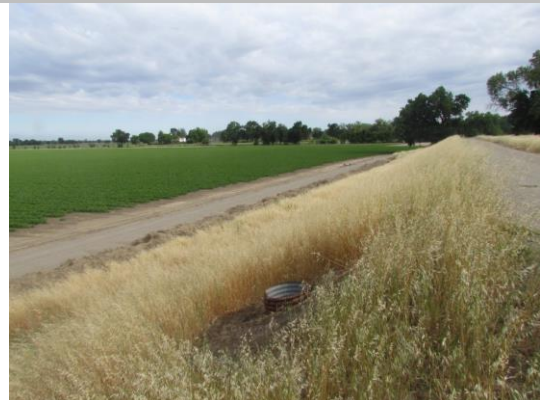
Photo 1 of 1 : SP\_2019\_NA0016\_435\_100\_20190304\_00034.jpg

LM Start	34.01	Rating **	M	Issue No.	100
LM End	34.07	Issue Type +	En	Location *	LS
Category	Earthen Levee			GPS Latitude/Longitude	
				Start	End
Item	Encroachments			39.087176 °	39.088099 °
				-121.896480 °	-121.896498 °
DWR ID	DWR_NA0016_01_f_2018_100				
Comment Code					
DT : Ditch					
Inspector Comment

View of the ditch at the landward side of the levee looking upstream. Spring 2015.

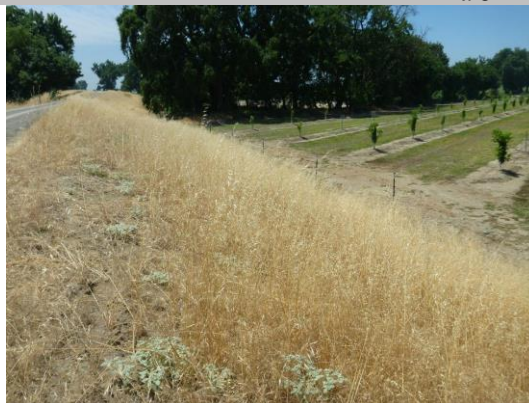
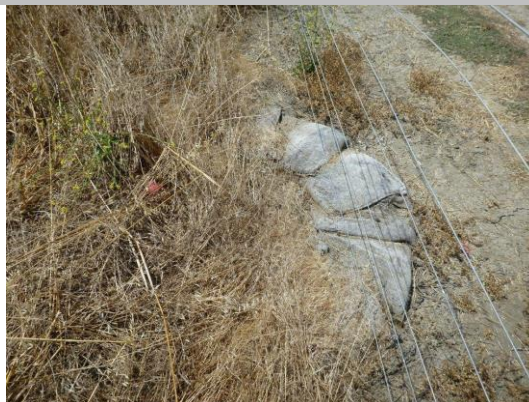
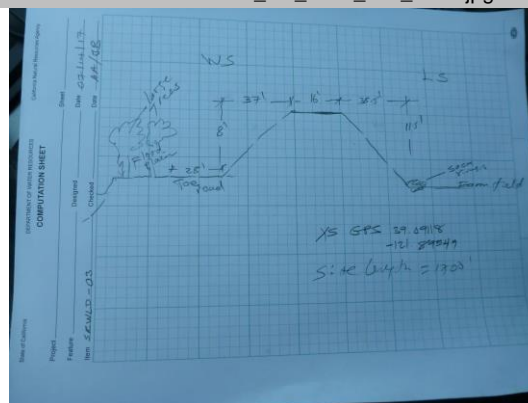
LM Start	34.24	Rating **	A/W	Issue No.	123
LM End	34.56	Issue Type +	Ob	Location *	
Category	Supplemental			GPS Latitude/Longitude	
				Start	End
Item	2017 Storm Damage			39.090511 °	39.094967 °
				-121.895675 °	-121.894858 °
DWR ID	DWR_NA0016_01_f_2017_123				
Comment Code					
Inspector Comment					
Levee Evaluation Comments					
Description:					
Site ID No:185					
Site Designation:SRWLD-03					
Repair Type: Seepage					
Rating:Critical					
Field Date:7/14/2017					
Notes: Well water tank 10' from LS toe & wire fence at LS toe					
Potential seepage berm site.

LM Start	34.24	Rating **	A/W	Issue No.	123 (cont)
LM End	34.56	Issue Type +	Ob	Location *	
Category	Supplemental			GPS Latitude/Longitude	
				Start	End
Item	2017 Storm Damage			39.090511 °	39.094967 °
				-121.895675 °	-121.894858 °
DWR ID	DWR_NA0016_01_f_2017_123				
Comment Code					
Inspector Comment					
Levee Evaluation Comments					
Description:					
Site ID No:185					
Site Designation:SRWLD-03					
Repair Type: Seepage					
Rating:Critical					
Field Date:7/14/2017					
Notes: Well water tank 10' from LS toe & wire fence at LS toe					
Potential seepage berm site.

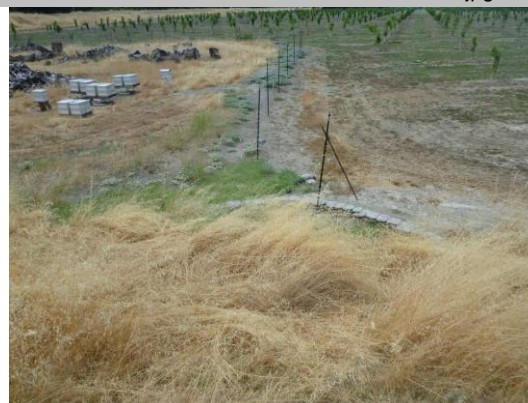
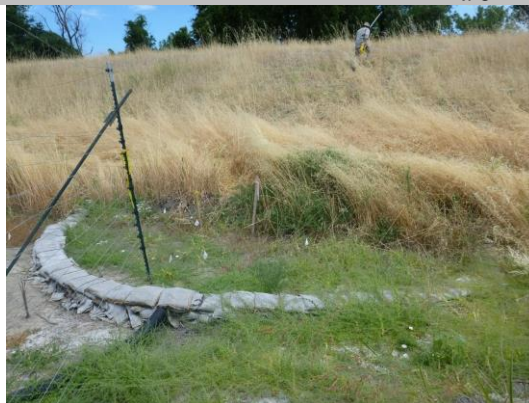
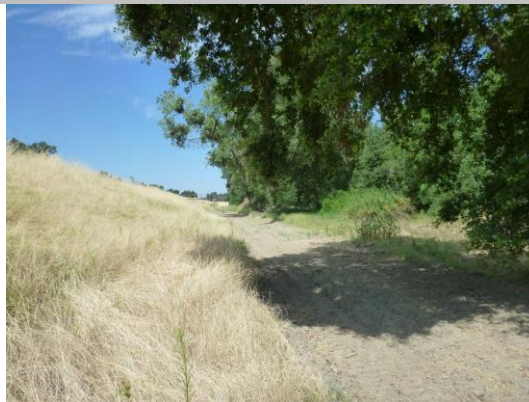
LM Start	34.65	Rating **	A/W	Issue No.	125	
LM End	34.72	Issue Type +	Ob	Location *		
Category	Supplemental			GPS Latitude/Longitude		
				Start	End	
Item	2017 Storm Damage			39.095592 °	39.095589 °	
				-121.896103 °	-121.897400 °	
DWR ID	DWR_NA0016_01_f_2017_125					
Comment Code						
Inspector Comment						
Levee Evaluation Comments						
Description:						
Site ID No:184						
Site Designation:SRWLD-02						
Repair Type: Seepage						
Rating:Critical						
Field Date:7/14/2017						
Notes: Potential seepage berm site.

LM Start	34.65	Rating **	A/W	Issue No.	125 (cont)	
LM End	34.72	Issue Type +	Ob	Location *		
Category	Supplemental			GPS Latitude/Longitude		
				Start	End	
Item	2017 Storm Damage			39.095592 °	39.095589 °	
				-121.896103 °	-121.897400 °	
DWR ID	DWR_NA0016_01_f_2017_125					
Comment Code						
Inspector Comment						
Levee Evaluation Comments						
Description:						
Site ID No:184						
Site Designation:SRWLD-02						
Repair Type: Seepage						
Rating:Critical						
Field Date:7/14/2017						
Notes: Potential seepage berm site.

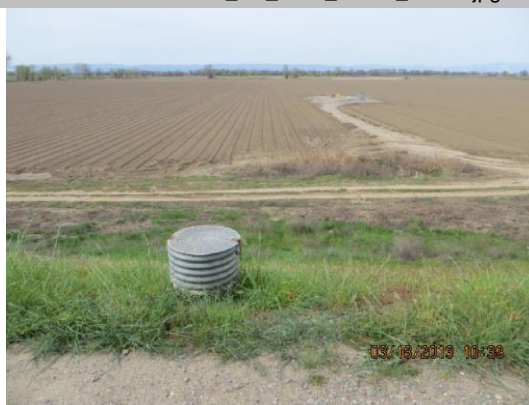
Photo 1 of 1 : UCIP\_SP\_2019\_10424\_17700.jpg

LM Start	35.56	Rating **	M	Issue No.	1595
LM End	35.56	Issue Type +	En	Location *	
Category	Supplemental			GPS Latitude/Longitude	
				Start	End
Item	DWR UCIP Field Study			39.103533 °	39.103533 °
				-121.906814 °	-121.906814 °
DWR ID	20273				
Comment Code					
Inspector Comment					
FS_ID:10424 DS_ID:20273 EP_NO: 9364A Repair Type: Non-Urgent Crossing Status: Found UCIP Comments: Need to verify type of abandonment. FIELD_STRUCT_DESC: 3 of 4: 18-inch steel irrigation pipe through the levee, 16 feet below the crown. Metal cutoff wall. Gate valve on the waterside (WS) bank. Siphon breaker in a 24-inch corrugated metal riser unit on the landside (LS) shoulder. (Automatic Board Order (ABO) issued as Permit No. 9364-A, 1974 - Alice Steidlmayer). [Additional Reference(s): DWR Levee Log, 2006. USACE Sacramento O&M Manual 131, May 1960 (HLM 36.04)]. FS Date: 3/18/2013

Siphon breaker in 24-inch CMP riser on LS shoulder.

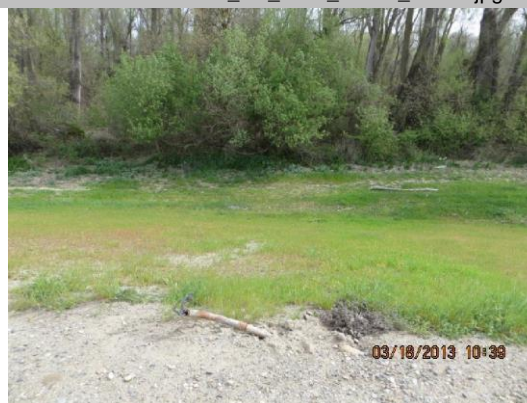
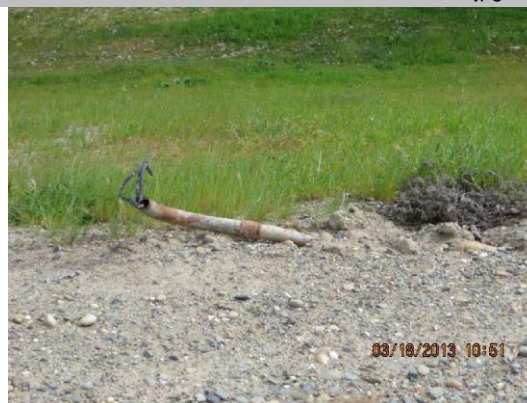
LM Start	35.56	Rating **	M	Issue No.	1596
LM End	35.56	Issue Type +	En	Location *	
Category	Supplemental			GPS Latitude/Longitude	
				Start	End
Item	DWR UCIP Field Study			39.103533 °	39.103533 °
				-121.906814 °	-121.906814 °
DWR ID	20398				
Comment Code					
Inspector Comment					
FS_ID:10425					
DS_ID:20398					
EP_NO: 9364					
Repair Type: Non-Urgent					
Crossing Status: Found					
UCIP Comments: Remove abandoned pipe from levee.					
FIELD_STRUCT_DESC: *ABANDONED* 4 of 4: 1.25-inch electrical conduit of an unknown material through the levee, 3 feet below the crown. (Automatic Board Order (ABO) issued as Permit No. 9364-A, 1974 - Alice Steidlmayer).					
FS Date: 3/18/2013

Electrical conduit on WS shoulder.

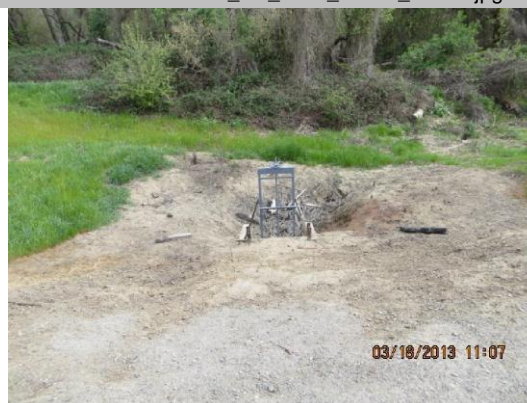
Photo 1 of 3 : UCIP\_SP\_2019\_10426\_17705.jpg

Comment Code						
Inspector Comment						
FS_ID:10426 DS_ID:20345 EP_NO: 9374 Repair Type: Non-Urgent Crossing Status: Found UCIP Comments: Verify if pipe is abandoned with landowner and remove or abandon properly if necessary. FIELD_STRUCT_DESC: *ABANDONED* 3 of 3: 24-inch concrete encased steel drainage pipe through the levee, 17 feet below the crown. Slide gate on concrete headwall on waterside (WS) end. Walkway to control gate and gate valve on landside (LS) end. (24-inch pipe [HLM 36.61] authorized under Automatic Board Order (ABO) issued as Permit No. 9374, 1974 - Richard H. Moore). [Additional Reference(s): USACE Sacramento O&M Manual 131, May 1960 (HLM 36.61)]. FS Date: 3/18/2013

Slide gate on WS toe.
